DEEP-OCEAN BIODETERIORATION
OF MATERIALS — PART III. THREE
YEARS AT 5,300 FEET

U. S. NAVAL CIVIL ENGINEERING LABORATORY
PORT HUENEME, CALIFORNIA

Technical Report R-428

James S. Muraoka

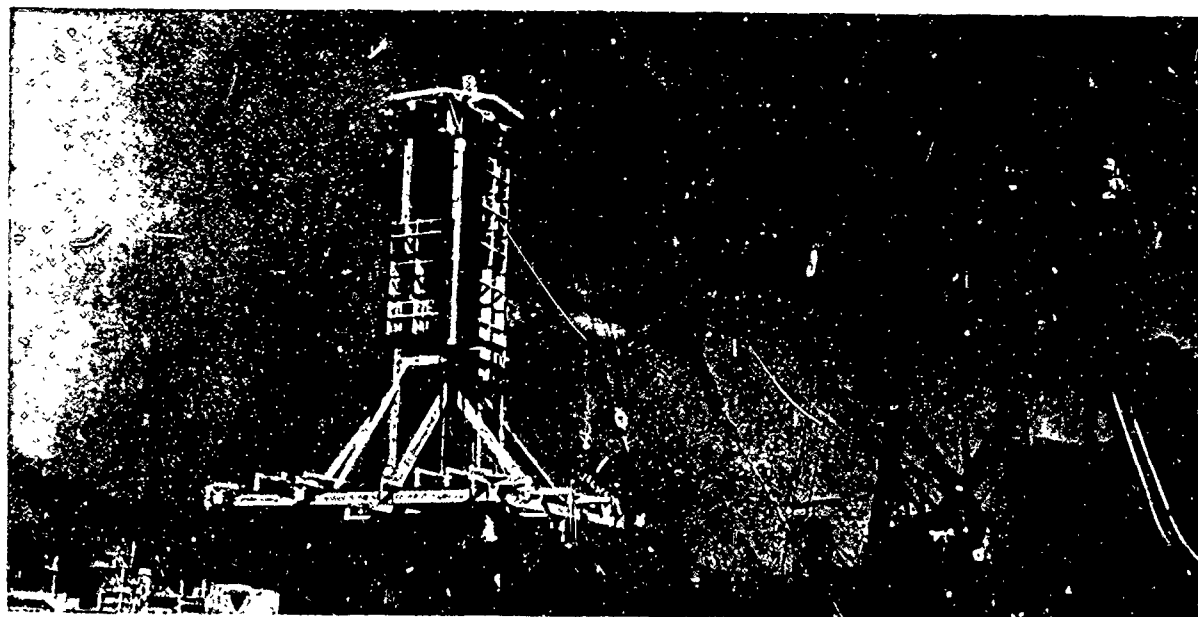
On 25 February 1965, STU I-1 loaded with 1,318 test specimens of 396 materials was the third STU to be recovered after 3 years (1,064 days) on the ocean floor in 5,300 feet of water (Figure 2). This report presents the materials and methods employed for attracting, collecting, and evaluating deep-ocean fouling and boring organisms, and the results of field and laboratory investigation of the recovered materials from STU I-1.

Figure 2. STU I-1 recovered from the sea being unloaded at dockside.

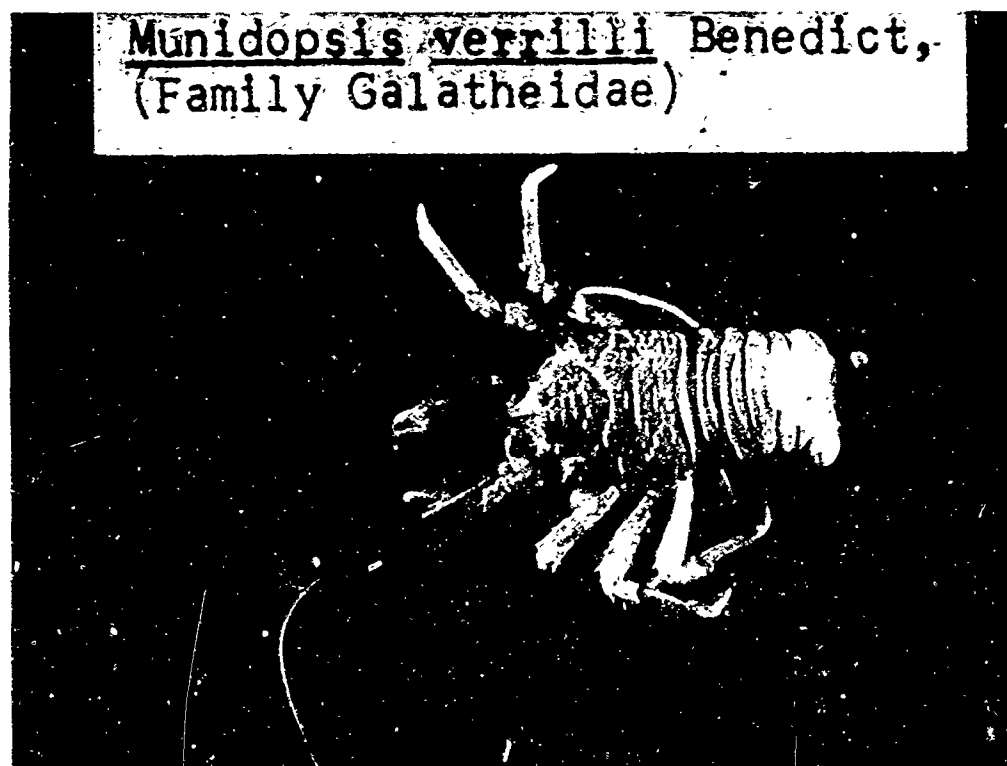
As soon as the STU was placed aboard the ship, it was examined for the presence of marine animals which were not attached to any of the test panels. The animals were collected and preserved in a 5-percent glycerol-alcohol solution for classification in the laboratory. One was a white lobsterlike crustacean with pinchers (Figure 22). The specimen was sent to the Smithsonian Institution for classification. It was identified as a galatheid lobster, Munidopsis verrilli Benedict (family Galatheididae). The animals found in the deep-ocean environment are normally dark colored, and finding a white crustacean on the ocean floor in 5,300 feet of water is very unusual.

Figure 22. A white lobsterlike crustacean found on the STU.
